Willow Community Library

Existing Conditions Survey of the Willow Community Center

March 30, 2015

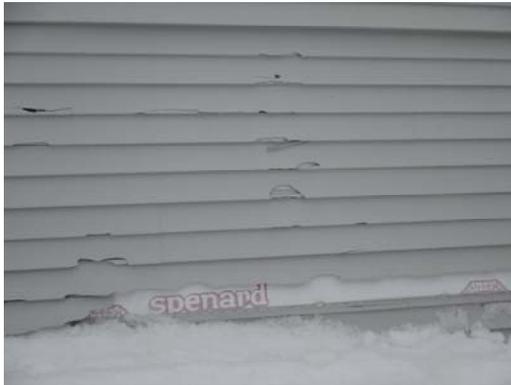
North Elevation

has not held up and is in poor condition. You will find cracked, chipped, and missing siding throughout the building although predominately on the East and North facades.

Replace all exterior siding with new pre-finished metal siding or other durable, low maintenance exterior siding product.

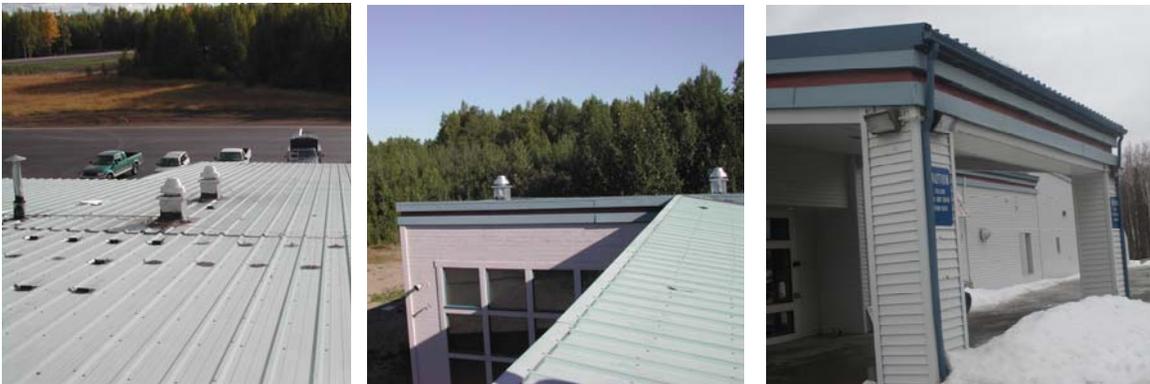
Ice accumulation on the roof has caused damage to roof and siding materials and poses a safety threat to pedestrians below. Sloped roof assemblies in this structure shed snow/ice toward walking and driving surfaces creating a hazard for most of the winter months. The design of this roof system is responsible for many safety issues and is also causing the re-occurring siding damage.

The roofing appears to be in fair condition in most areas and only minor leaks have been observed in the second level mechanical space. Occupants did not mention roof leaks in any other interior spaces that were causing an issue. The metal roofing system is assumed to be the same age as the building and will be nearing the end of its useful life in approximately 6-10 years.

It is recommended the roofing and flashing be replaced fairly soon. (ten years maximum).

Install additional ventilation for the North roof system. Some possible options might include:

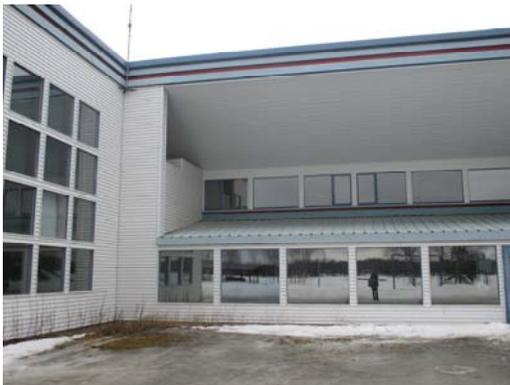
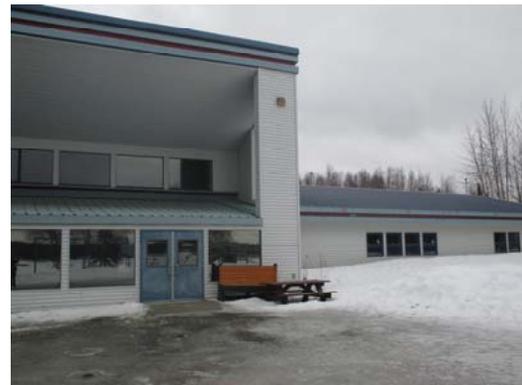
Glazing in and around doors is required to be either safety glazing or tempered glazing. In many cases the glass in the doors and windows is standard plate glass. It is assumed that the plate glass was of original install and the tempered and safety glazing are replacement glazing units.

It is recommended that the glazing in all doors, side lights, re-lights adjacent to doors, an large panes of glass adjacent to walking surfaces be evaluated for type and if identified as standard plate glass, that glazing be removed and replaced with tempered or safety glazing.

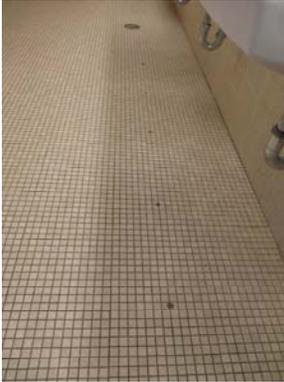
Toilet Rooms

Original 1x1 unglazed ceramic tile, Worn, Fair condition, some damaged tile from floor anchors

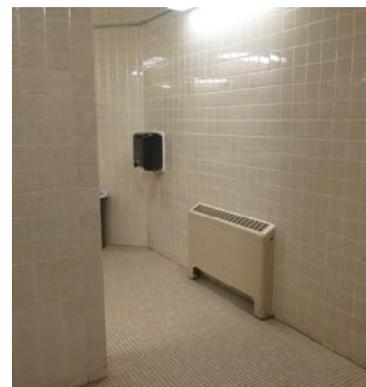
Toilet rooms

The walls in the common use toilet rooms are 4"x4" glazed ceramic tile. The tile is original and for the most part is in good condition although there is some tile damage in both the Men's and Women's toilet rooms.

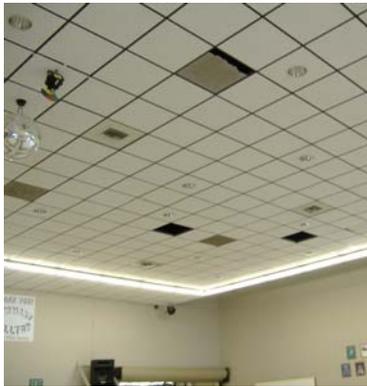
Community Hall

GWB and Suspended Acoustical Tile (ACT) assemblies throughout. The Community Hall, Kitchen, and Common Use circulation areas are fitted with the original suspended acoustic ceiling systems and are in fair condition having some broken, missing, and some discolored ceiling tiles throughout. The Common use bathrooms, utility rooms, Library, Vestibules, and platform ceilings are painted GWB and in generally good condition.

Replace damaged, stained, and missing ceiling tiles / clean all diffusers.

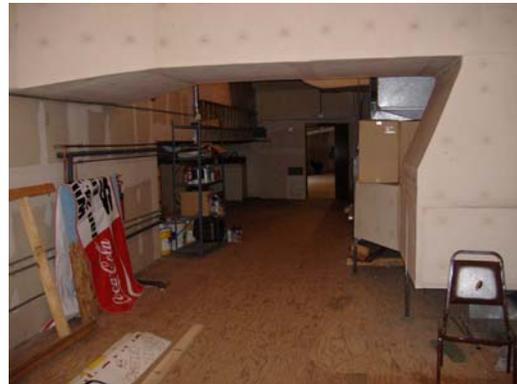
Utility Space

Utility Space: The walls in the utility space are level 1 GWB with no painted finish. The GWB is in good condition but staining is evidence that some leaking has occurred in the roof over the years.

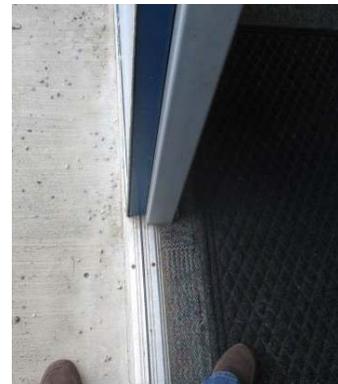
Threshold View

The double door is 34 inches wide per door. The threshold is more than ¾ inches in height change. The door panic hardware is located 35 inches off of floor.

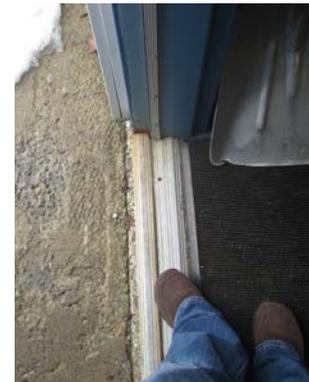
Threshold View

There is a single door that is 35 inches wide with exit handles at 37 inches off of the floor. The threshold is more than ¾ inches from exterior grade. The concrete landing has some spauling.

Repair spauled concrete at landing.

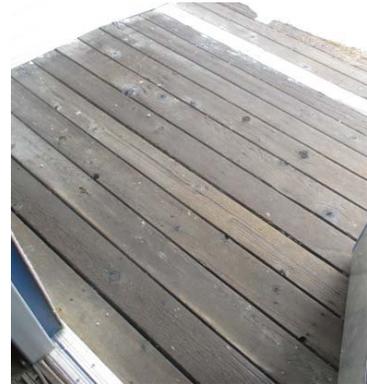
Threshold View

There are double doors that are 34 inches wide each. The height to handles is 32 inches exterior and 35 inches interior for the exterior door and 40 inches interior and 29 inches interior for the vestibule door. The exit lands at a wood ramp on the West side of the building. The wood ramp has a 1.5:12 slope leading to grade. The threshold height is at ¼ inch. The interior rug has curling edges that could be a tripping hazard.

Replace the floor mat to prevent tripping hazard.

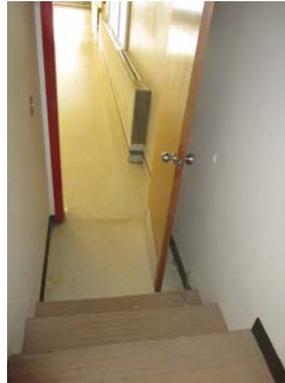
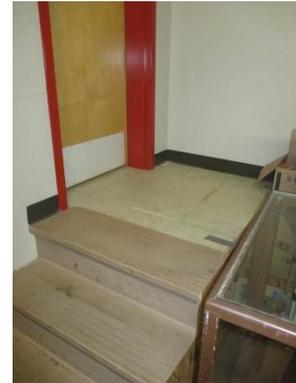
The stage is 24 inches off of the floor and provides stair access at each side from the Community Hall and also at each wing room. Doorways to access the stage off the wing rooms are 31 inches wide. The right side wing room has a landing prior to the stage entrance that is 36 inches wide by 53 inches deep with no handrail and loose tile flooring.

Install a 36 inch minimum guardrail at wing room landing and repair flooring tiles.

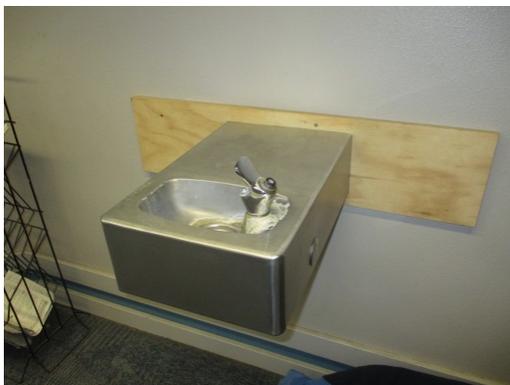
Fountain in Main Hall

The drinking fountain is 35.5 inches off of the floor to the top and is 30 inches clear to the underside. It projects 19 inches from the wall and is 4.5 inches from the front to the spout and 15 inches from the spout to the wall. It appears to not be functioning and is in need of repair.

Repair and replace missing parts of the fountain to be in working order. Lower fountain so that clear underneath height does not exceed 27 inches.

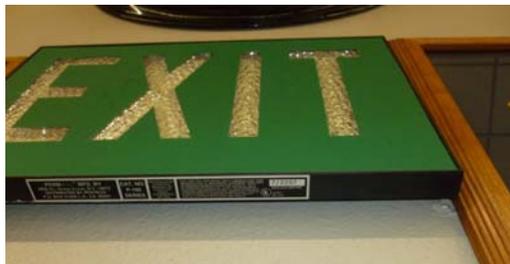
1. Exit signs are expired. The current exit signs use tritium, a radioactive material that is required to be disposed of in an approved manner. Since they are expired they are no longer bright enough and must be replaced.

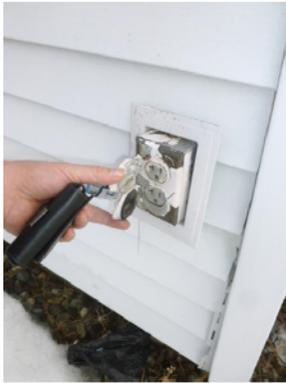
2. Exterior receptacles are required to have in-use covers on them. At the time of installation they would have been compliant but with recent code changes they no longer are.

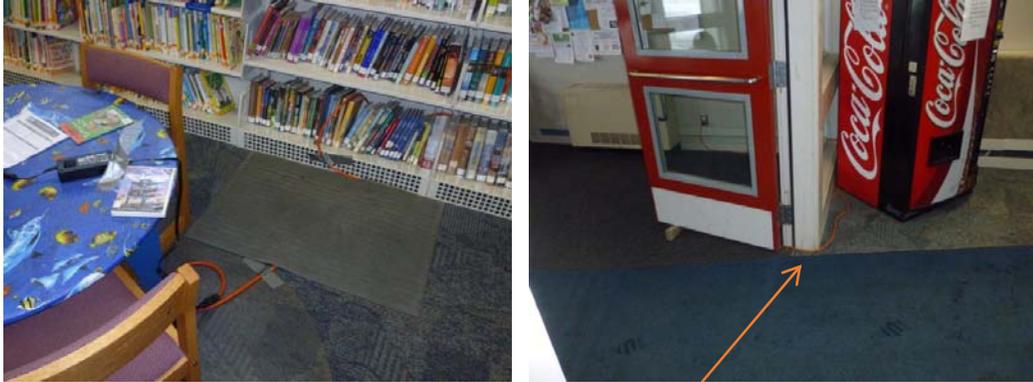
Cord thru doorway

3. Extension cords are not allowed as permanent wiring. There is clearly a lack of receptacles in the library and so extension cords are used in several locations. There were no complaints about breakers tripping so there is enough capacity it is just that the receptacles are not where they are needed. Although this should be fixed at all locations throughout the building the biggest issue is in the entry way where the cord is going through a door. The opening and shutting of a door on a wire quickly destroys the insulation and becomes a fire and safety issue.

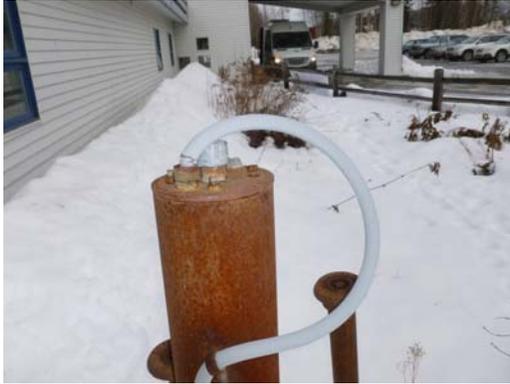
4. The conduit fitting at the well head has been broken and needs to be replaced.
