Willow Community Library

Existing Conditions Survey of the Willow Community Center

March 30, 2015

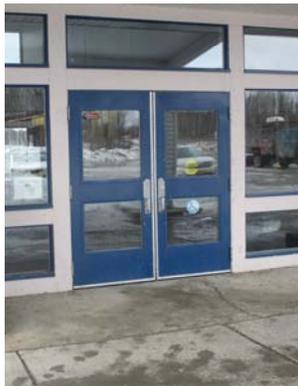
East Entry Door

The exterior doors appear to be insulated hollow metal doors with welded hollow metal frames. The doors and hardware appear to be in good to fair condition.

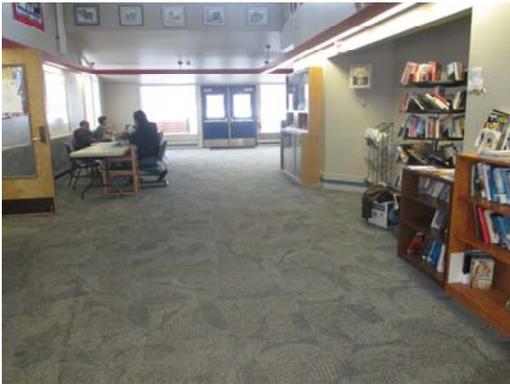
Entry Hall

The common areas have been recently re-carpeted and the flooring is showing some wear but is in relatively good shape.

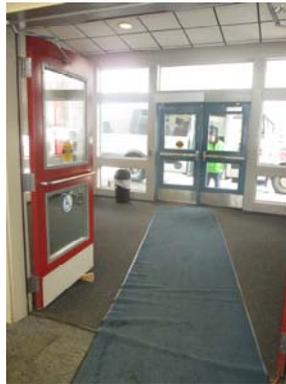
Entry Vestibule

Entry Vestibules have been recently re-carpeted and the flooring is in good condition.

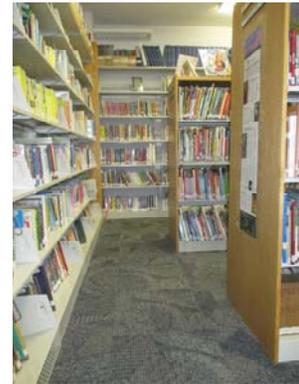
Library

This area has recently been re-carpeted with broadloom carpeting the flooring is in good condition and does not show much wear

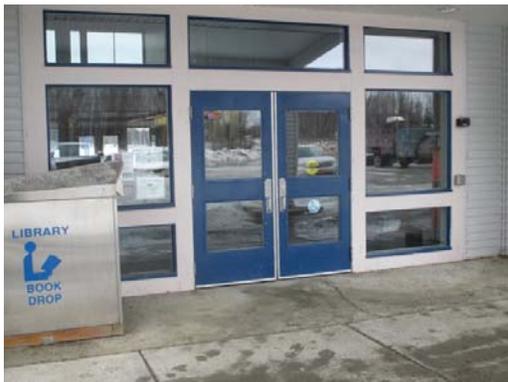
Exterior View

The double entry door has an auto-door opener that is 37" off of floor, manual operator pulls on the exterior at 31", and panic hardware on the interior at 39". Both doors are 34.5" wide. The threshold is at a proper height. The entry rug, in the vestibule, spans across the vestibule door threshold, buckling in places causing a possible tripping hazard. The vestibule doors are each 35.5" wide with a proper threshold.

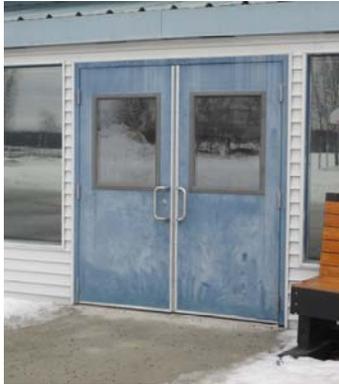
Exterior View

The double door is 34 inches wide per door. The threshold is more than ¾ inches in height change. The door panic hardware is located 35 inches off of floor.

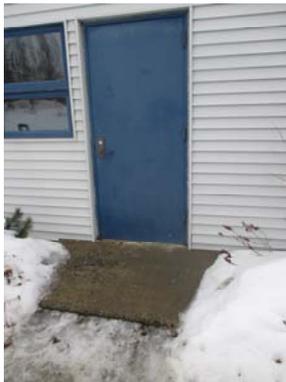
Exterior View

There is a single door that is 35 inches wide with exit handles at 37 inches off of the floor. The threshold is more than ¾ inches from exterior grade. The concrete landing has some spauling.

Repair spauled concrete at landing.

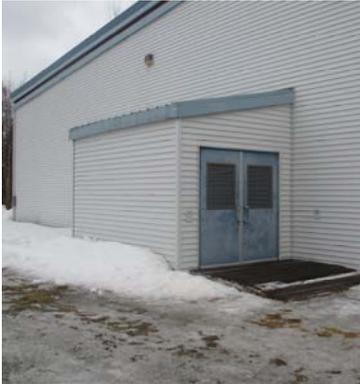
Exterior View

There are double doors that are 34 inches wide each. The height to handles is 32 inches exterior and 35 inches interior for the exterior door and 40 inches interior and 29 inches interior for the vestibule door. The exit lands at a wood ramp on the West side of the building. The wood ramp has a 1.5:12 slope leading to grade. The threshold height is at ¼ inch. The interior rug has curling edges that could be a tripping hazard.

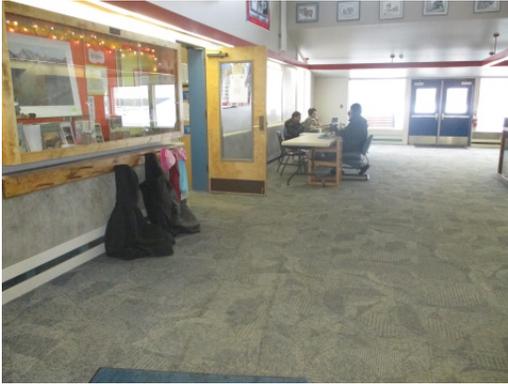
Library Entrance

The Library entrance provides an opening of 33 inches and has adequate space for approach on the pull side of the door. The entrance to the Community Hall is through two sets of double doors that provide 34 inches of opening each.

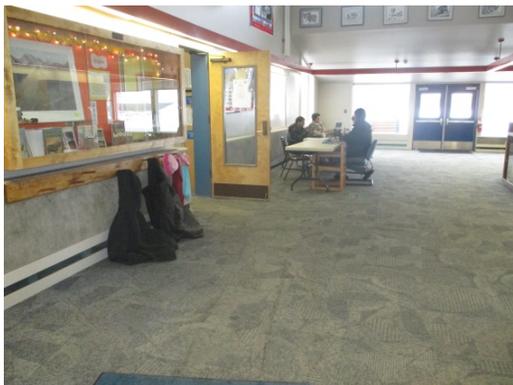
Hall to Library

The hall is clear of obstructions and provides ample wheelchair turn around space. All projections on the path are less than 4 inches and/or are less than 27 inches off of the floor.

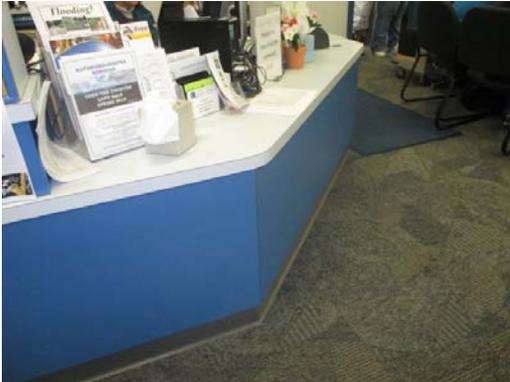
Library Service Counter

The reception counter is 27 inches off of the floor and is the full depth of the counter. The counter provides a parallel approach for wheelchairs.

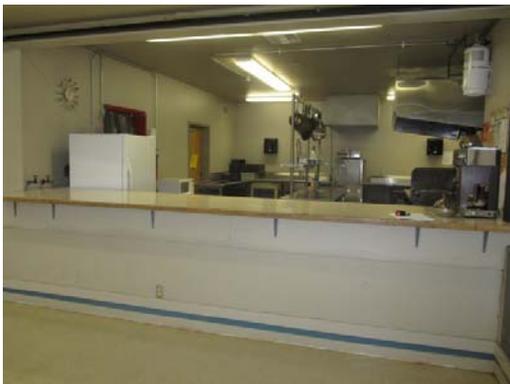
Kitchen Service Counter

The service counter is 41 inches off of the floor with a 10 inch front overhang. The counter provides a parallel approach for wheelchairs.

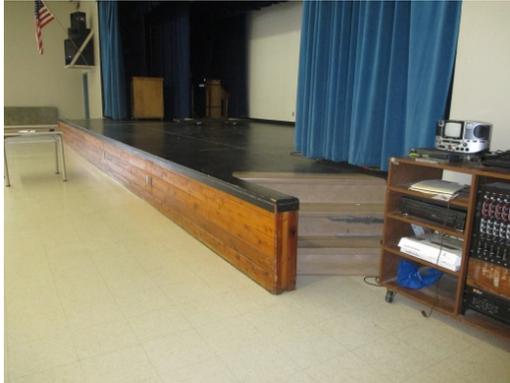
Stage Front Access

The stage is 24 inches off of the floor and provides stair access at each side from the Community Hall and also at each wing room. Doorways to access the stage off the wing rooms are 31 inches wide. The right side wing room has a landing prior to the stage entrance that is 36 inches wide by 53 inches deep with no handrail and loose tile flooring.

Install a 36 inch minimum guardrail at wing room landing and repair flooring tiles.

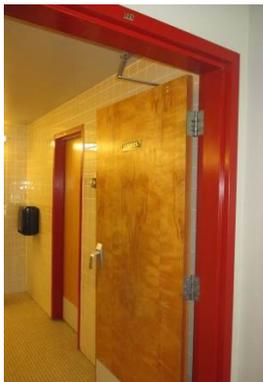
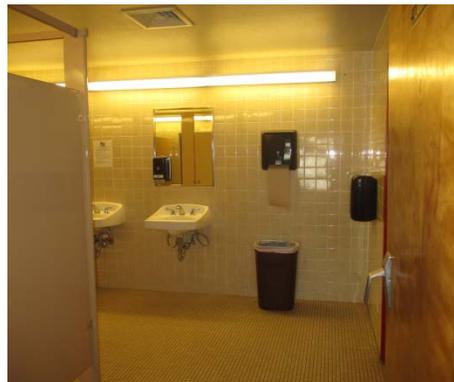
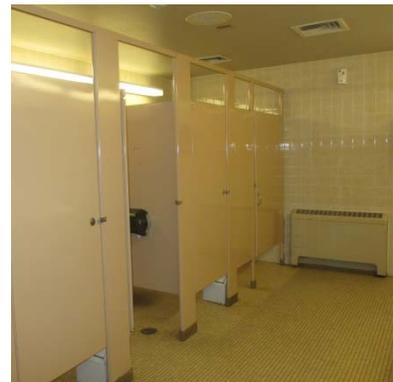
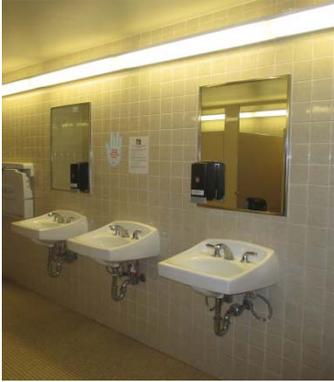
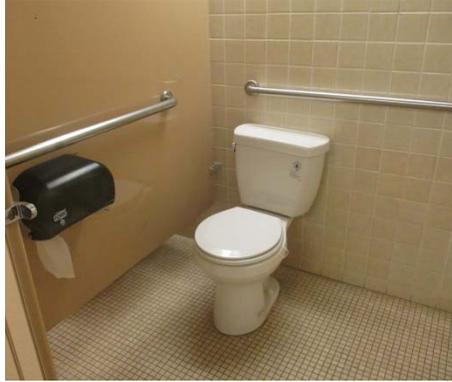
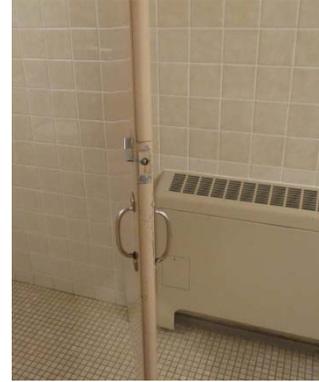
There is a shower room located off of the main toilet room with a door that is 27 inches wide. The shower stall is 34 inches by 31 inches with controls at 48 inches off of the floor. The shower room provided is not ADA accessible due to entrance door width and shower stall size.

Provide/install proper ADA room signage.

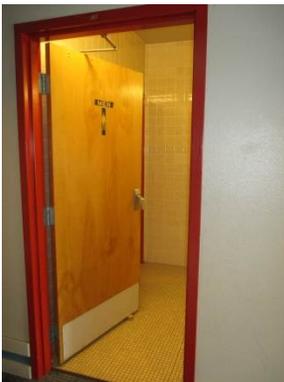
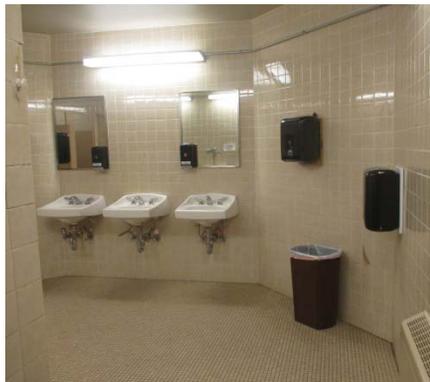
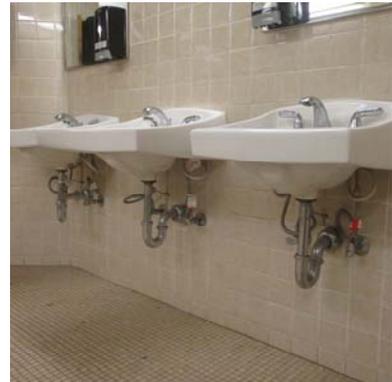
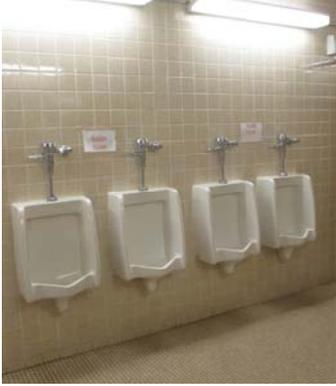
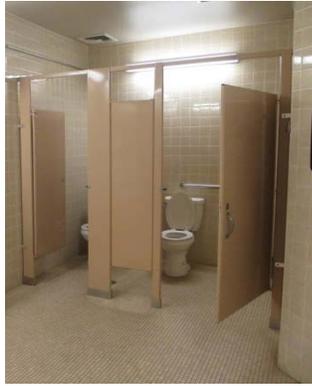
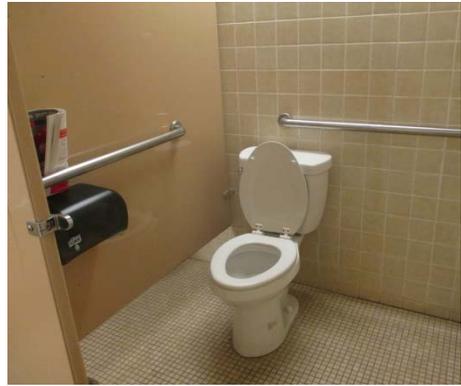
- Shower Room

There is a shower room located off of the main toilet room with a door that is 27 inches wide. The shower stall is 34 inches by 31 inches with controls at 48 inches off of the floor. The shower room provided is not ADA accessible due to entrance door width and shower stall size.

Provide/install proper ADA room signage.
