Tyone Lake 2014 Data Summary

Tyone Lake Snapshot

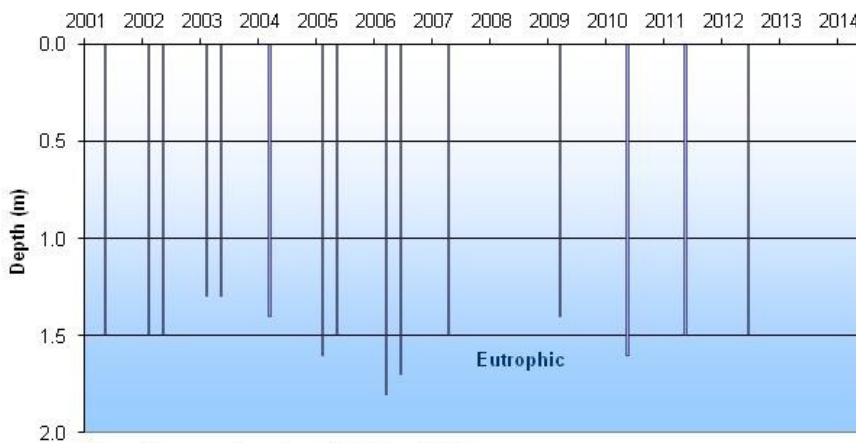
Tyone Lake • Secchi Data 2001-2014

*Tyone Lake was not monitored in 2008 and 2013
